US Army Corps of Engineers Construction Engineering Research Laboratories

Investigation of Fiberglass-Reinforced Plastic (FRP) Condensate Return Carrier Piping

by
Orange S. Marshall, Jr. and Charles P. Marsh

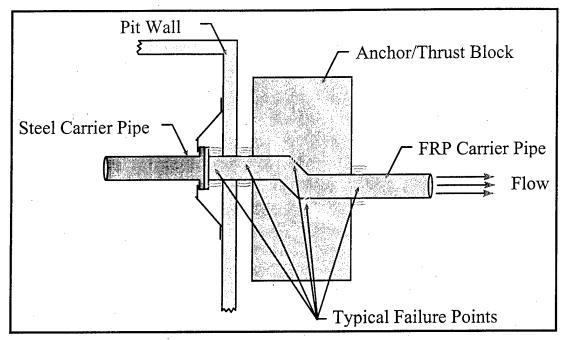
When the FRP pipe breaks, it is typically either in or within a few inches of the manholes or the concrete anchors (Figure 4). This may have several causes, including: (1) settling of the manholes and anchors over time, (2) settling of the anchor and not the manhole, or vice versa, (3) ground heave from freeze-thaw in cold climates, (4) thermal expansion and contraction of the pipe, or (5) a combination of two or more of any of these. When the pipe breaks, a significant

Figure 4. Typical failure points around manholes.

length of adjacent pipe is also damaged, requiring additional excavation and testing to find sound pipe to attach a repair section of pipe to.
